Hydraulic Model Investigation
Of Marsh Creek Dam Principal Spillway
In Contra Costa County, California

ARS-NC-35
February 1976

Study conducted by the
Agricultural Research Service
UNITED STATES DEPARTMENT OF AGRICULTURE

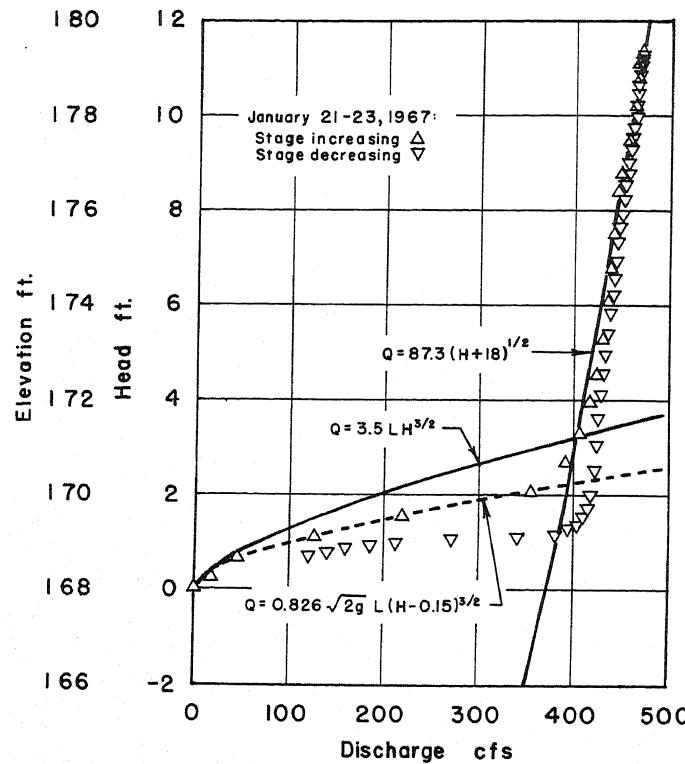
FIGURE 5.—Prototype head-discharge relationships.

Using these recorders' data and the stage-storage relationship of the reservoir, the average rate of flow through the principal spillway for successive 1-hour periods was computed as the algebraic sum of the rate of change of storage and the average inflow rate. These computations were made in the SCS California State Office in August 1968. The results are shown in figure 5.

Kalkanis' weir flow and conduit control curves have been added to figure 5 to illustrate his comments.

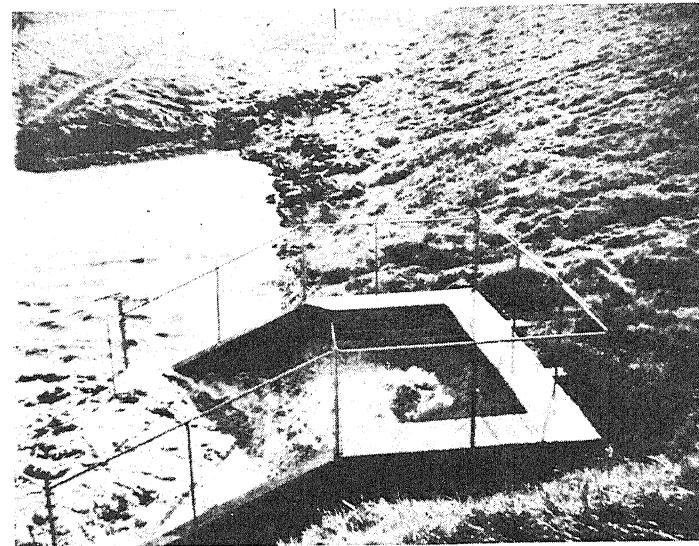
1. At 10:10 a.m. the water surface at principal spillway was indicated to be (—) 0.1', by the painted scale on the hood, below the crest which is supposed to be constructed at elevation 168.0'. An audible roar of falling water could be heard even when inside the recorder building on top of the dam. All of the (8) 4"Ø vent holes on the north face of the spillway appeared to be partially to completely plugged with debris. (Ref. photo No. 1).

Photo No. 1.—1/27/69 w/s [water surface] at inlet indicated at —01 10:10 a.m.

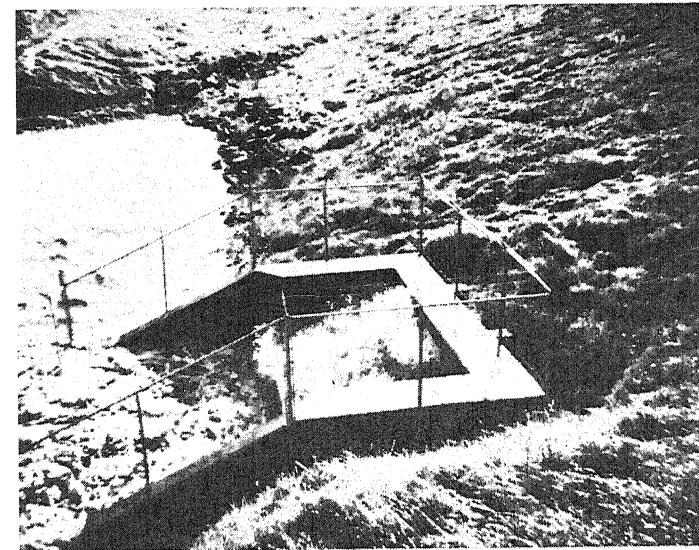
2. At 10:15 a.m. the discharge in the energy dissipator was turbulent and it appeared that the 4.5'×4.5' spillway tube was flowing full. (Ref. photos No. 2 & 3).

Photo No. 2.—1/27/69 10:15 a.m. [No air expelled.]

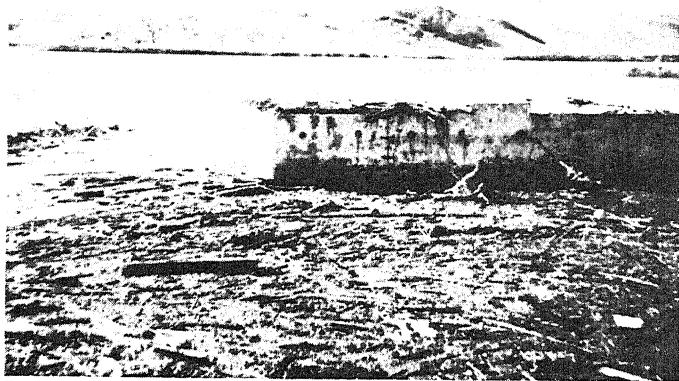
Photo No. 3.—1/27/69 10:15 a.m.
[Air transported through the barrel is expelled intermittently.]

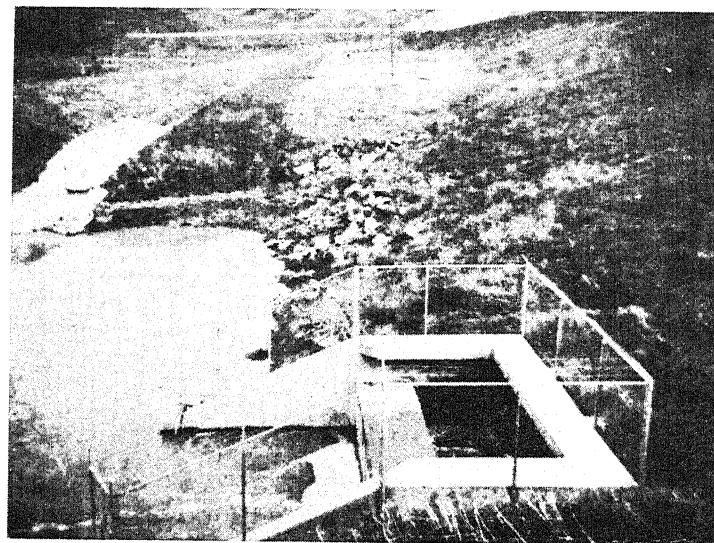
1. Photo No. 6 shows the indicated water surface to be 1.0' over the principal spillway crest. A very slight audible sound was heard at the spillway which could not be readily heard from on top the dam. Note the debris in some of the 8 vents on the south face of the hood.

Photo No. 6.—1/29/69 West face of Princ. Splway [principal spillway].
w/s [water surface] appeared to be at indicated 1⁰ above crest elevation.
2:30 p.m.

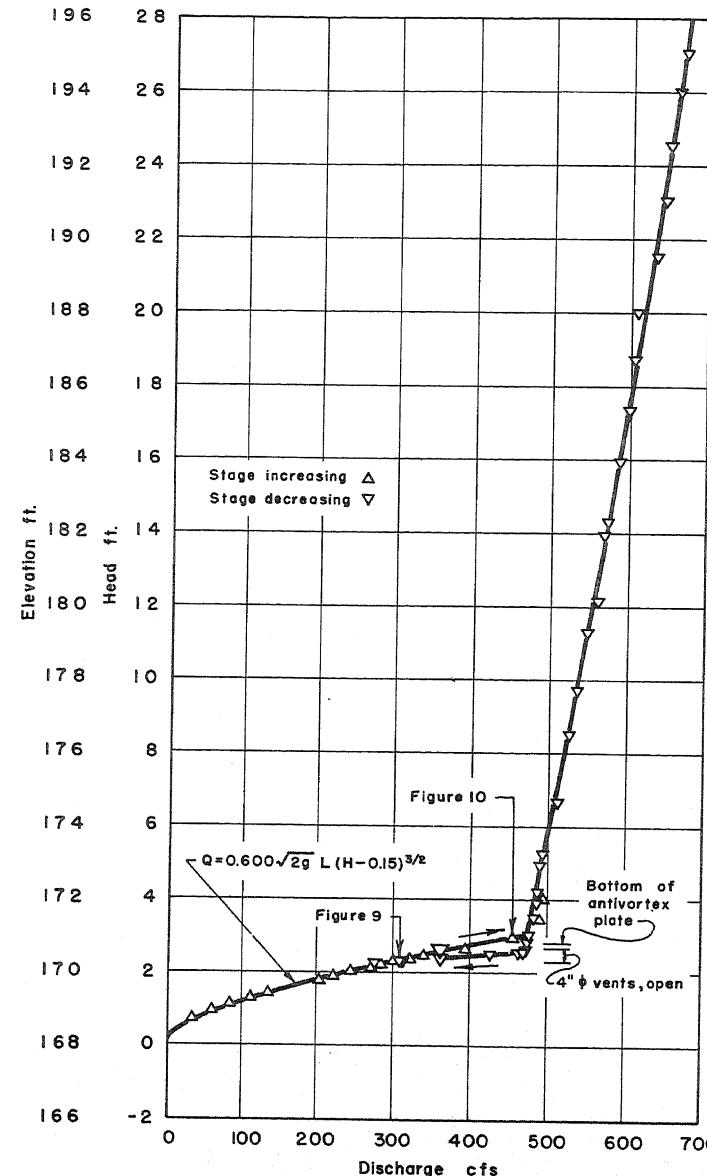
Figure 8.—Model head-discharge relationship: vents open.

The head-discharge relationship with open ports in the endwalls is shown in figure 8. Although figure 8 has been expressed in prototype units, quantitative model-prototype similarity does not exist for full flow because of the different barrel lengths and the omission of the energy dissipator. However, similarity for weir flows should exist.

The head-discharge relationship is unique for rising and falling stages except for the hysteresis effect as the control changes from pipe to weir on falling stages. This hysteresis is believed to be caused by inadequate ventilation because, during the falling-stage hysteresis portion of the head-discharge curve in figure 8, the vents are partially submerged and apparently are unable to fully supply the venting requirements.

For discharges up to 473 c.f.s. the head-discharge relationship was controlled by the weir at the drop inlet crest. For discharges less than 270 c.f.s. the nappes clung to the sides of the drop inlet, the barrel was part full, and the barrel flow was supercritical except near the barrel exit where there was an undular hydraulic jump.

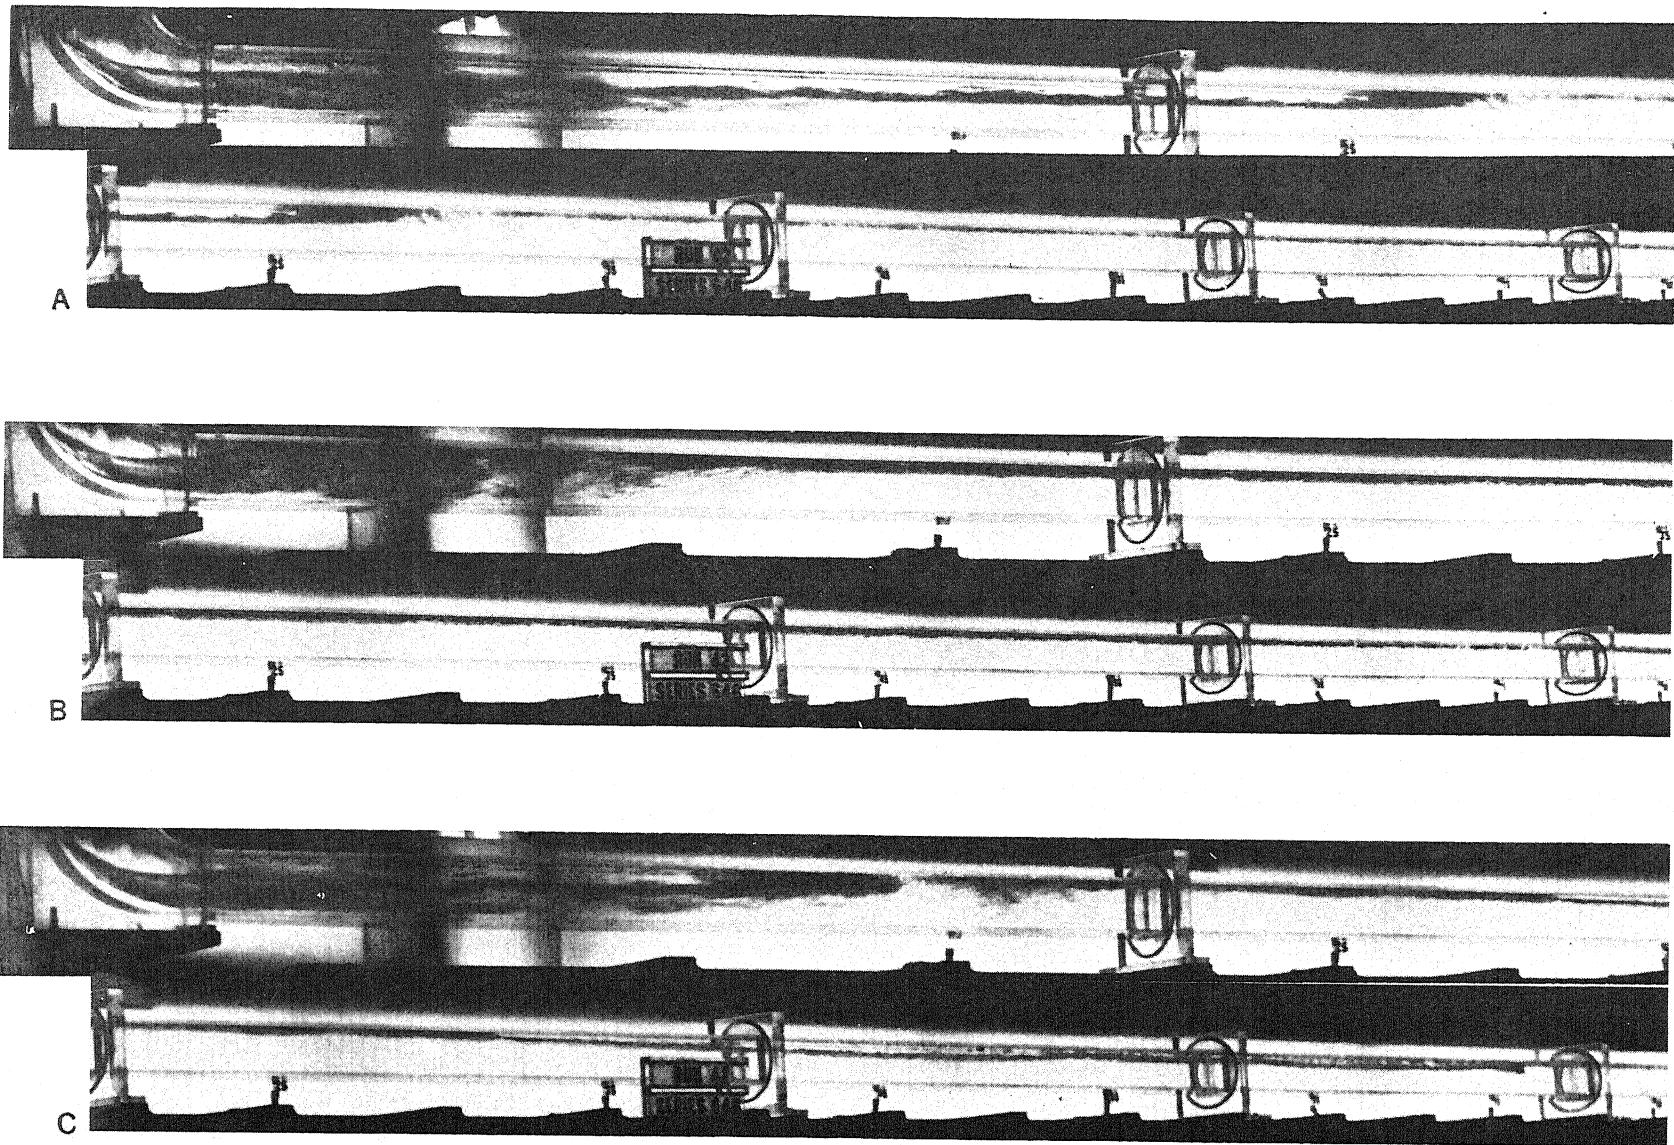
Unstable flow existed in the barrel at discharges of 300 to 320 c.f.s. There was a hydraulic jump in the barrel. The air entrained in the jump was transported as small bubbles (fig. 9(a)) or larger slugs (fig. 9(c)) on the barrel crown. The jump position was unsteady, slowly moving back and forth in the barrel or remaining

Figure 9.—Various flow conditions in the barrel, discharge 309 c.f.s. (The upper section of each photograph shows the bottom of the drop inlet and the barrel from 0D to 35D, the lower section shows the barrel from 20D

to 85D.) (A) Hydraulic jump in barrel at 27D from barrel entrance. (B) Jump has moved to upstream end of barrel. (C) Jump at 12D and long air slug from 31D to 77D.

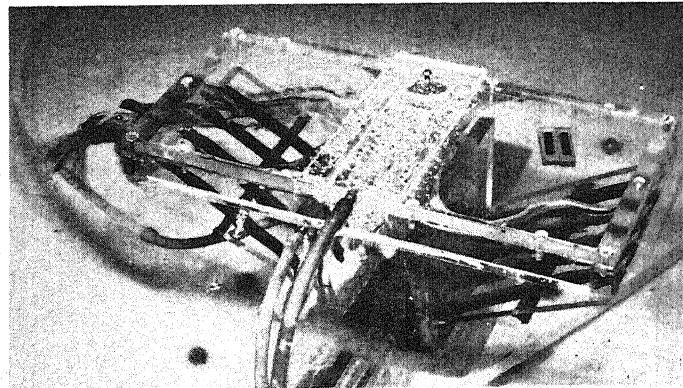
Figure 10.—Vents open, head 2.95 ft, discharge 457 c.f.s. Small vortex at left upstream corner of antivortex plate, air trapped under upstream outside corners of antivortex plate, splash on underside of antivortex plate over drop inlet, weir control, drop inlet partly full, air being entrained by nappes.

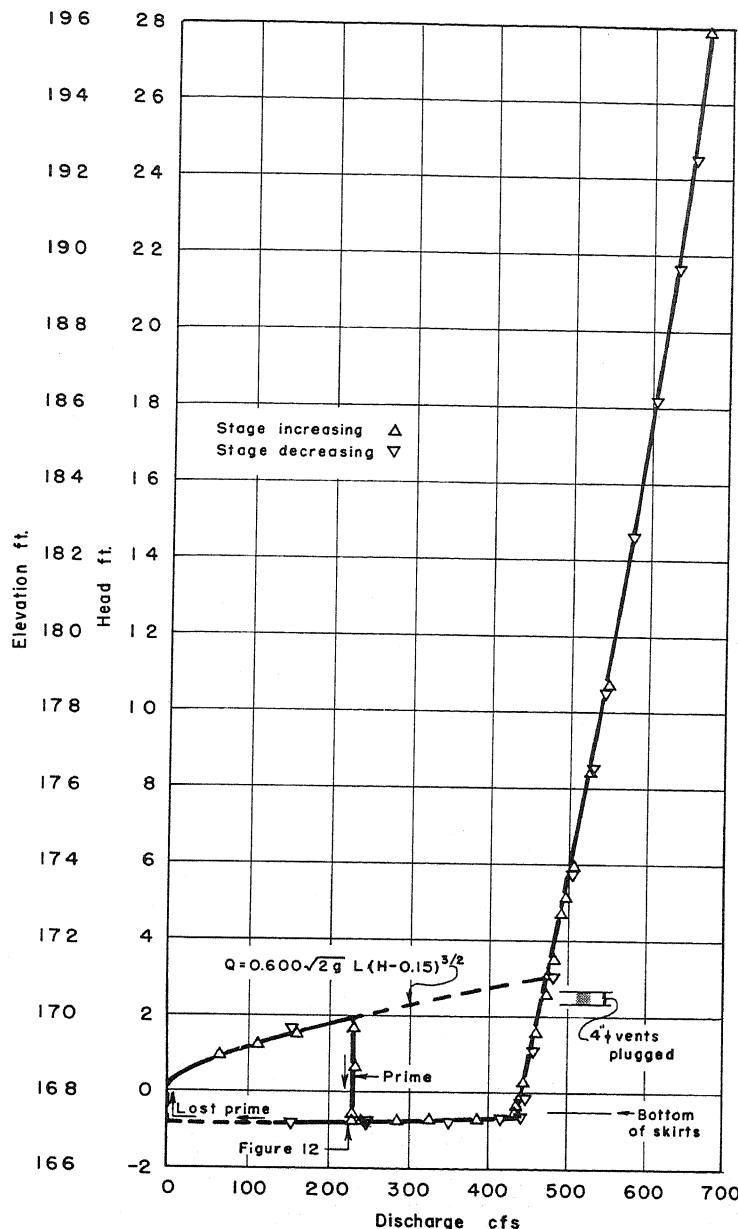
Figure 11.—Model head-discharge relationship: vents closed

As the discharge increased from 229 to 433 c.f.s., the drop inlet gradually filled and the air entering under the skirts gradually decreased. One of the weir nappes clung and the other sprung free.

There were surface vortices at the ends of the antivortex plate for heads between 2.5 and 11 ft. Air bubbles were trapped under the upstream outside corners of the antivortex plate at heads exceeding 4 ft. Air was trapped over the drop inlet at a discharge of

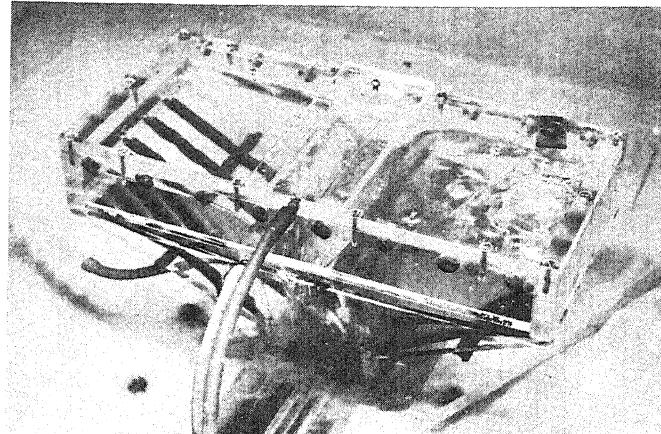
FIGURE 12.—Vents closed, head -0.8 ft, discharge 229 c.f.s. Siphon-regulated flow, air entering from under antivortex plate skirt, drop inlet partly full.

500 c.f.s. and the pressure blew off the manhole cover, an event which was observed only once during the tests.

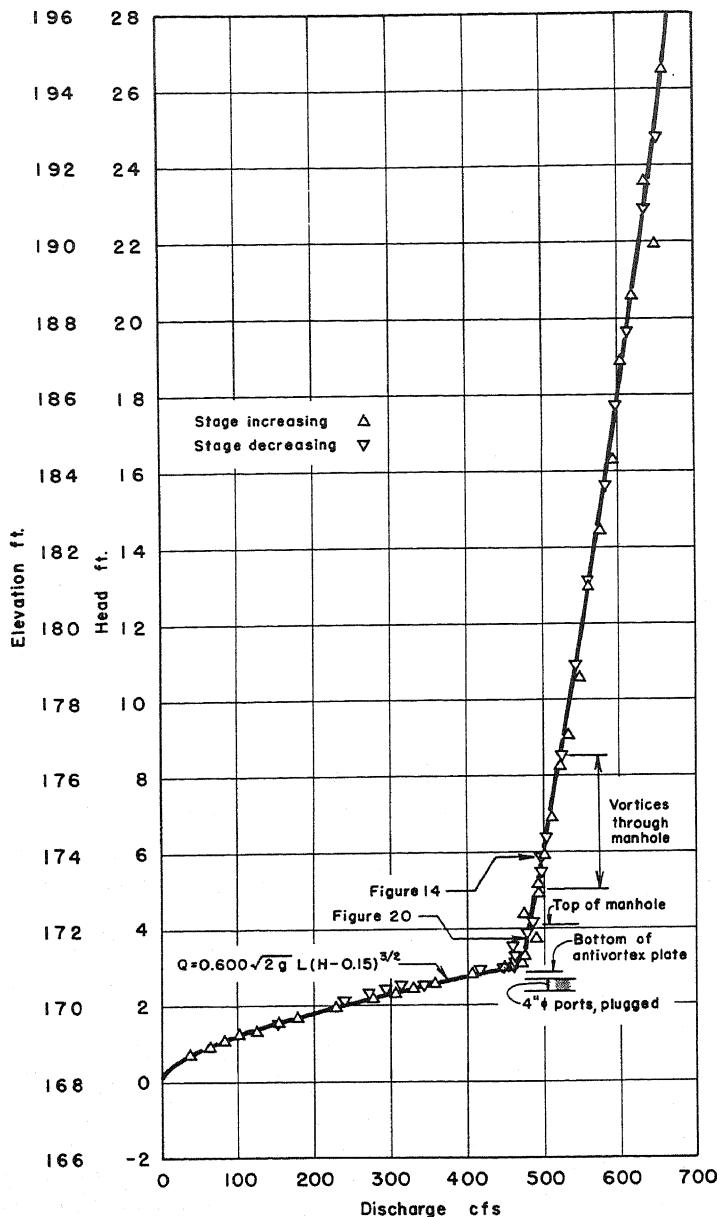
Figure 13.—Model head-discharge relationship: vents closed, manhole cover

The head-discharge relationship with the endwall vents plugged but with the manhole cover removed is shown in figure 13. Venting of the spillway was through the open manhole. The head-discharge relationship is seen to be unique; there was no suggestion of a hysteresis loop caused by inadequate venting.

The drop inlet crest, acting as a weir controlled the head

discharge relationship for all discharges less than 470 c.f.s. and all heads less than 3.0 ft. The nappes were clinging on rising stages but one nappe was free on falling stages. The drop inlet did not completely fill during weir control. On rising stages the barrel sealed due to the formation of a hydraulic jump at a discharge of about 300 c.f.s. On falling stages the barrel remained full down to a discharge of less than 240 c.f.s. Air was transported through the barrel during weir control.

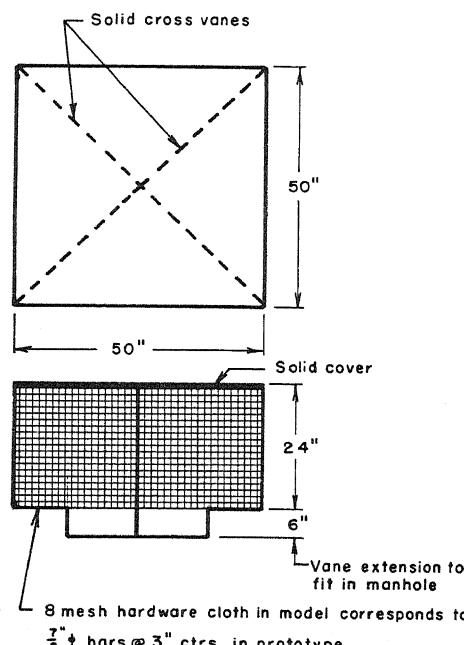
Figure 15.—Manhole trashrack and antivortex device.

This series of tests was made to determine if an antivortex device would control vortex formation. The antivortex device tested is dimensioned in figure 15. Although the vortices observed during the previous series of tests did not disappear until the antivortex plate was submerged 4.5 ft, the antivortex vanes were made only 24 inches high. They extended diagonally across a trashrack 50 inches square. This size was based on the largest trashrack that could be conveniently placed over the manhole. Because the antivortex vanes were too low to prevent vortex formation when the vanes were submerged, a solid cover was provided for the vanes and trashrack. The model trashrack was made of 8-mesh hardware cloth. This wire spacing corresponds to 3 inches in the prototype.

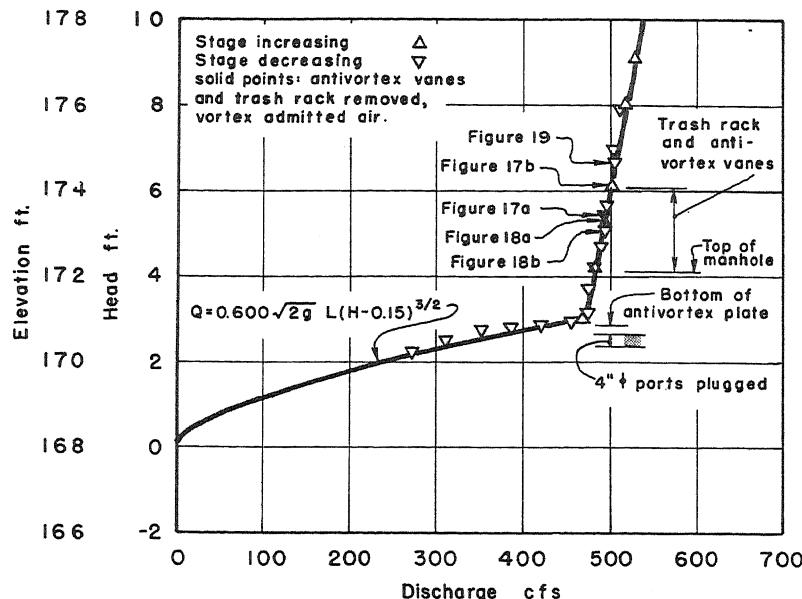
Figure 16.—Model head-discharge relationship: vents closed, manhole cover removed, trashrack and antivortex device over manhole.

Similarly, the trashrack cover was used only after the trashrack and antivortex vanes became submerged. At times during the tests the trashrack and antivortex device were removed to see if vortices would form; they did.

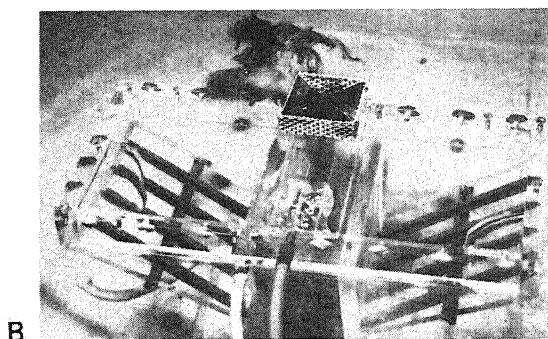
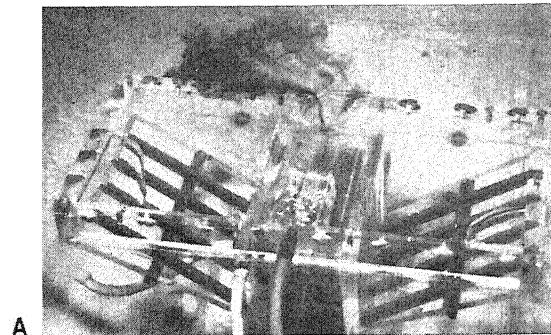
Without the antivortex device a vortex formed over the manhole as shown in figures 17(a) and 18(a). The vortex was absent when

Figure 17.—Without and with a manhole antivortex device air is trapped under the upstream end of the antivortex plate cover at three places: over the drop inlet and at the outer ends. (A) Dye shows vortex core, head 5.4 ft. (B) Unsubmerged antivortex device permits vortex formation, head 6.2 ft.

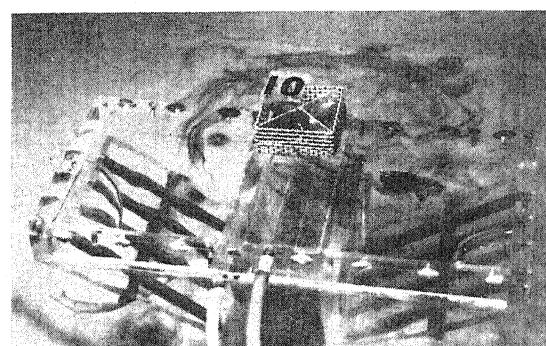
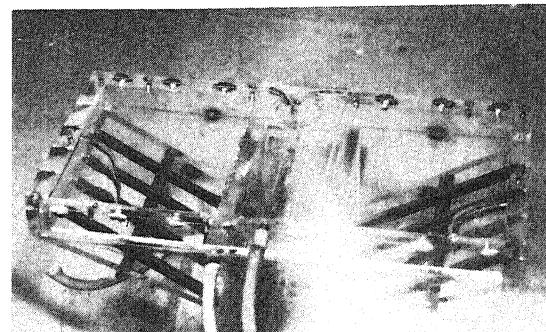
Figure 18.—Similar to figure 17 except the air over the drop inlet has been exhausted by entrainment at higher discharges. (A) Vortex and air core, head 5.3 ft. (B) Unsubmerged antivortex device prevents vortex formation, head 5.0 ft.

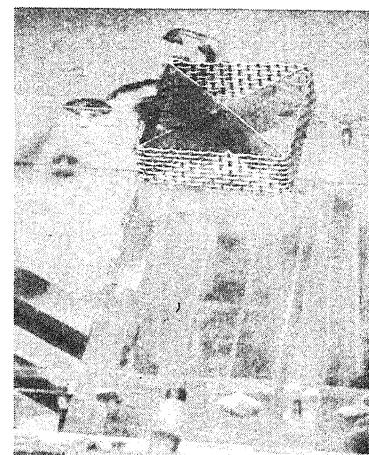
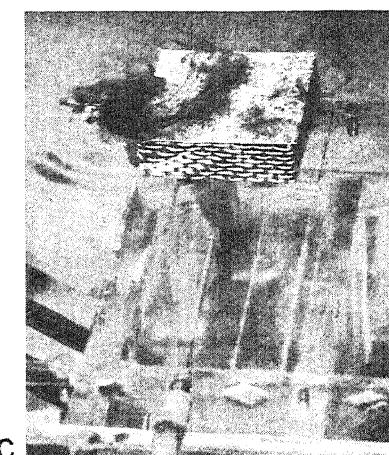
vanes were submerged 0.9 to 0.5 ft, fig. 19(b)) which were eliminated completely when the trashrack cover was installed (fig. 19(c)).

Figure 19.—Effect of various elements of manhole antivortex device, head 6.6 ft. (A) No antivortex device, dye shows air core extending through

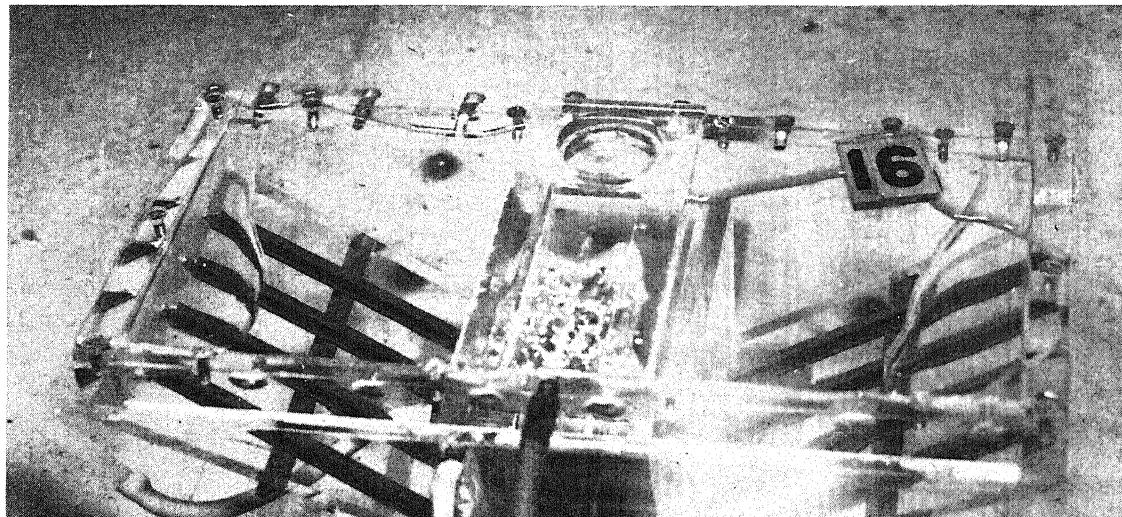
Figure 20.—Little loss in head between the headpool and drop inlet. Water is standing in the manhole opening. The head on the spillway crest is 3.7 ft, 0.9 ft above the bottom of the antivortex plate. The pressure at the center of the antivortex plate is 0.5 ft. The pressure drop between

the headpool and the cover over the center of the drop inlet is only 0.4 ft or $-0.04h_{vp}$. Air is trapped over the upstream end of the drop inlet and upstream outer ends of the antivortex plate.
